COACH MODEL : C 2045, T2100, T 2145, Model Year 2006 to Present

DATE : March 1 2014

SUBJECT : Interior Temperature Sensor Replacement

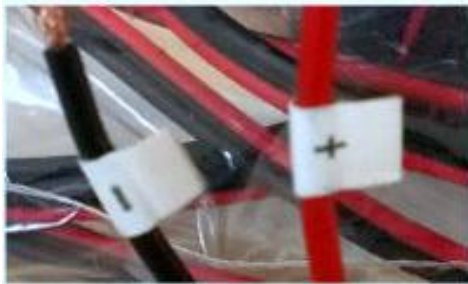
Replacement of the interior temperature sensor with 4 wires can be confusing since there are two red wires and two black wires. The red and black wires on the new sensor with the + & - stickers are the power and ground wires for the fan.

The red and black wires associated with the fan connect to the purple and brown wires from the coach. Red (+) to purple and black (-) to brown.

The white and brown wires wrapped in a gray sheath, originating from the coach, are signal wires for the temperature sensor and shall be connected to the red and black wires from the sensor without decals, red to white and black to brown.

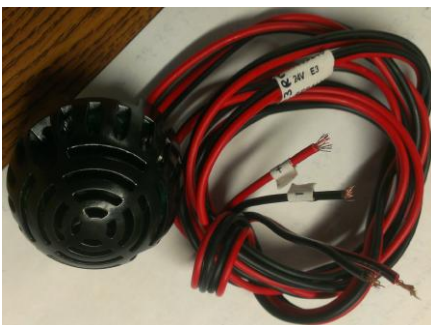
Measure the resistance of one set of wires (each set are fused together at the jacketing, one red, one black). Refer to the maintenance manual temperature charts located in the climate control section. Review the chart of temperatures and corresponding resistances i.e. 4700 ohms at 77 degrees Fahrenheit. The set of wires associated with the fan will have a resistance of approximately 170K ohms.

Temperature sensor assembly

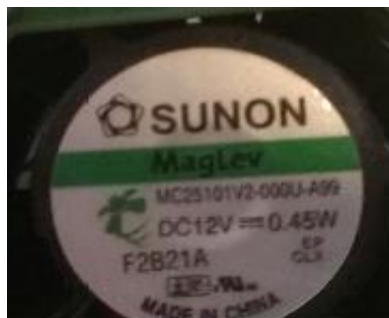
The motor associated with the fan is rated nominally at DC12V but is compatible with the 24V system utilized on Van Hool coaches.
